Q: “How Do PolyLube™ Bearings Withstand *E-Coating & Other Painting Processes?*”

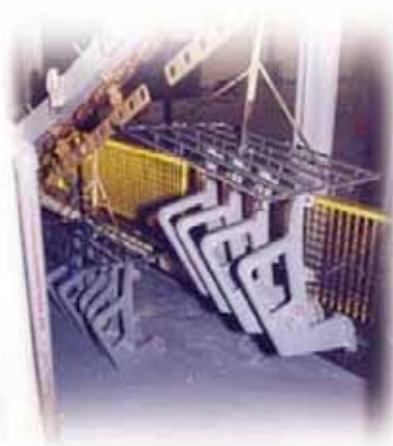
The e-coat process itself relies on the chemical principle that “opposites attract.” Typical e-coat processes generate a DC charge on a metal part. The metal part itself is, at the time of this charge application, fully immersed in a solution of oppositely charged paint. The two steps in most continuous e-coat systems are the pretreatment zone and the electrocoat bath. It is in these baths that corrosive chemicals are applied in order to clean and in some cases chemically etch the metal substrate in preparation for the depositing of paint. During these two steps the PolyLube bearings can be exposed to the chemicals within the bath. Polygon’s internal chem lab has completed multiple long term immersion studies where samples of the composite structure are put through concentrated chemical baths of equivalent chemical agents, for equivalent exposure times, and at equivalent temperature settings.

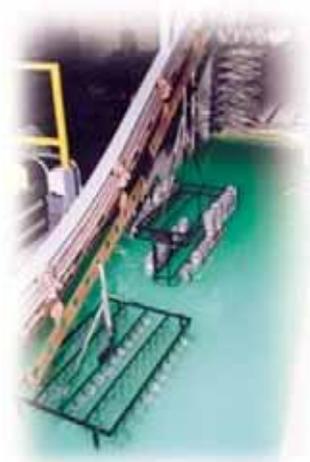
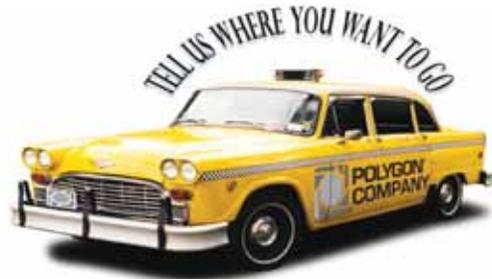
Maintaining Liner Integrity & Mechanical Capacity of the Backing:

The second point focuses on whether or not the liner itself or the backing material is negatively effected by the baking process required to cure most paint systems. Cure techniques vary widely but most are within the 375-400°F range. The PolyLube bearing employs a thermoset resin system that is capable of performance functioning in ±325°F temperature range. The short term duration of the paint curing process is not a potential problem for PolyLube bearings. Because the resin chemistry of PolyLube bearings is thermoset, and not thermoplastic, the PolyLube bearing is not capable of a flow condition, regardless of temperature. The thermal gradient employed by e-coating and other painting processes does not impact the performance of the product. What can be seen at times is a slight color change from a light yellow to a darker color—the color change can be unnoticeable or can be a more dramatic change, depending on the time of the exposure. This is a common condition in the composites' industry called “greening.”

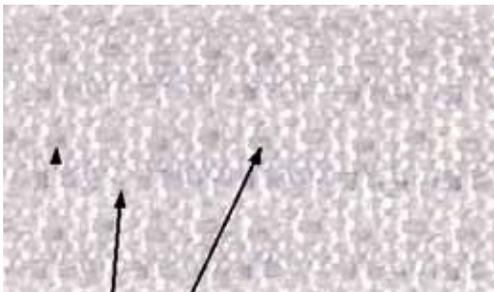
Contamination of the PolyLube bearing ID will not create performance problems assuming the paint is similar in its spread as to the above picture. As the pin cycles through its oscillatory or rotational degree of movement, the paint will easily and quickly come off the PTFE liner and the PTFE film transfer process will continue unabated.

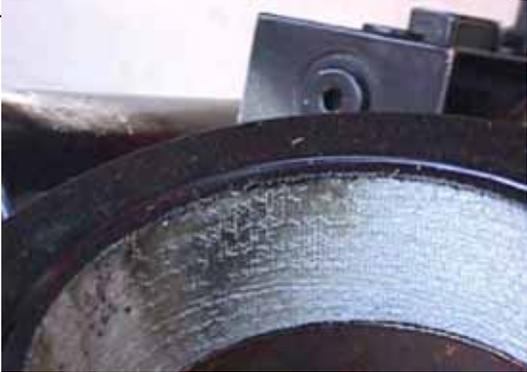
*PolyLube journal bearing liners employ a proprietary liner architecture that have engineered “pockets” that allow for the ingestion of contamination—regardless of the type of contamination in question. In the case of paint, the paint is quickly removed from the PTFE filaments and embed themselves into the pockets, allowing the bearing to continue functioning. This is a **unique feature** to the PolyLube Fiber and MRP family.*

It is here that a distinct performance enhancement for Polygon's line of PolyLube bearings exists. The PolyLube Fiber and MRP series bearings employ a proprietary liner architecture that is capable of easily ingesting significant contamination without fully inhibiting the film-transfer process and the overall performance of the bearing itself.
